Project Title: Stent cleaning

**Overview:** The COMCO Applications Lab received the following sample stents for oxide removal. The current process for removing all oxide from the stents is with an automated process, blasting from the OD only. A maximum weight of 5% can be removed from the stent during blasting. The primary objective is to remove only the oxide. The daily production rate is 180 stents/day.

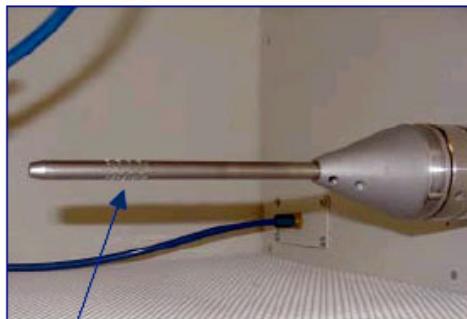
Stent loaded in lathe for OD blasting:  
 supported by mandrel, ready to be blasted.

**Set-up and Procedure:** The stents were treated using an abrasive lathe. The abrasive lathe is a semi-automated machine, controlling nozzle speed, position, part rotation, and blast parameters during blasting. Each stent was blasted first from the OD, then the ID. During OD blasting, the stent was supported on a mandrel (see picture below) while an array of 4 nozzles traveled over the stent at a consistent speed, blasting the stent. After OD blasting, the stent was installed in an ID mandrel, and an ID nozzle traveled through the axis of the stent to remove the remainder of the oxide. Blast parameters (pressure, powder, nozzle size, etc.) were chosen based on COMCO's experience with similar processes. All blast parameters including processing time/stent are listed below.

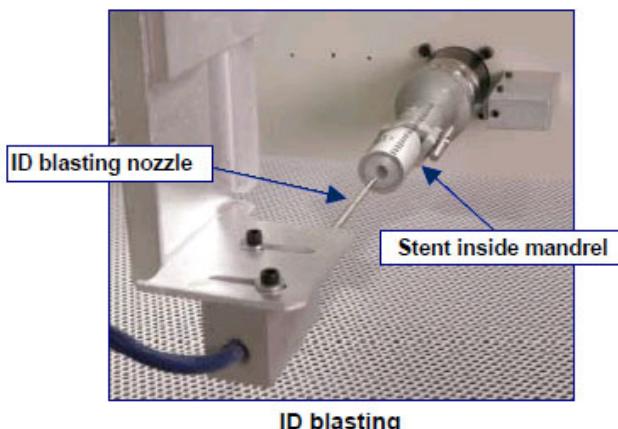
ID blasting

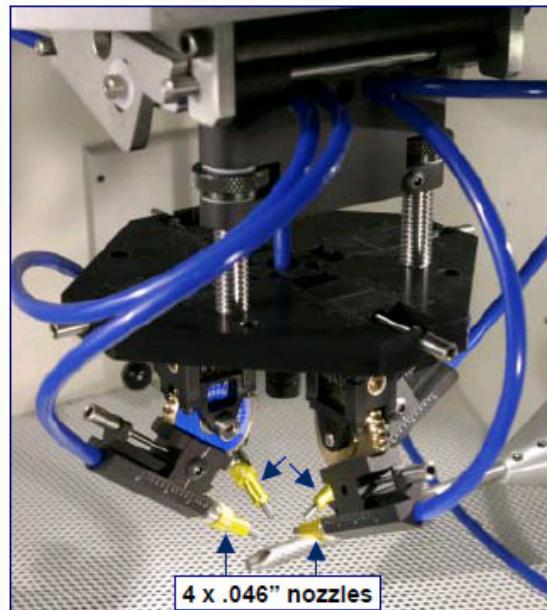
Engineering OD blast head

OD Head Configuration	Nozzle	Theta Adjustment	Tangential adjustment	Radial adjustment	Head z adjustment
	1	25	0.5	0.10	.8
	2	30	0.9	0.91	
	3	25	0.5	0.10	
	4	30	0.9	0.75	
	5	Not used

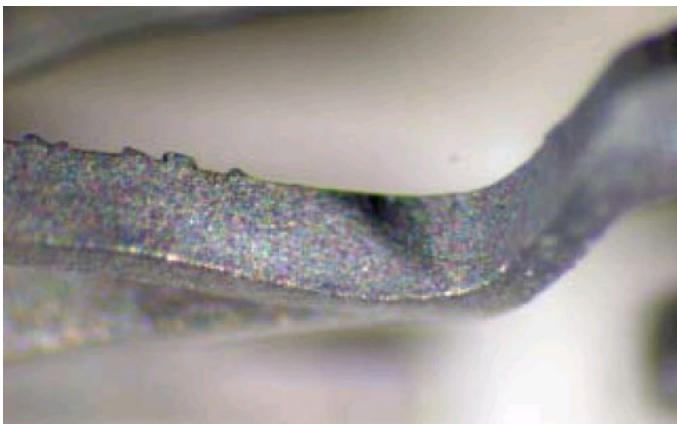
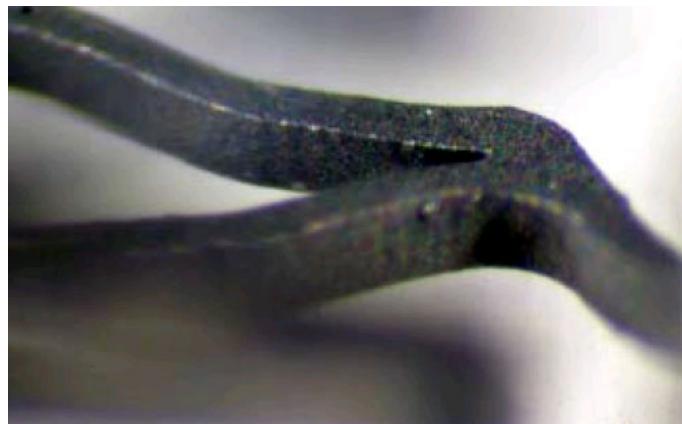
Surface finish of samples 1-5. Oxide removed. Some sharp edges and pulse lines on walls are still present.

**Test Parameters and Results:** Listed below are the before and after weights of the stents. Stents 1-5 are within the 5% limit of material removal. All oxide was removed from these stents. These samples (1-5) were blasted at a relatively low pressure (25 psi) and still have remnants of pulse lines as well as sharp edges. Comco processed two additional samples (10, 11) at a higher pressure (70 psi) in order to remove the pulse lines and radius the edges. As shown with samples 10 and 11, it is possible to achieve a relatively smooth surface finish; but will require greater than 10% material removal. If only the oxide is to be removed as originally requested, the material removal rate will remain below 5%.

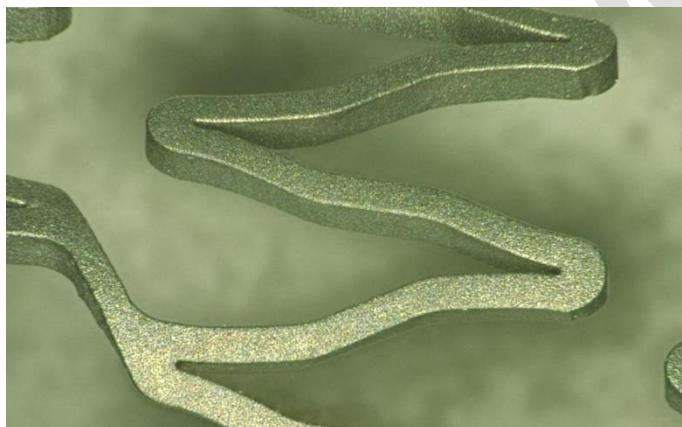
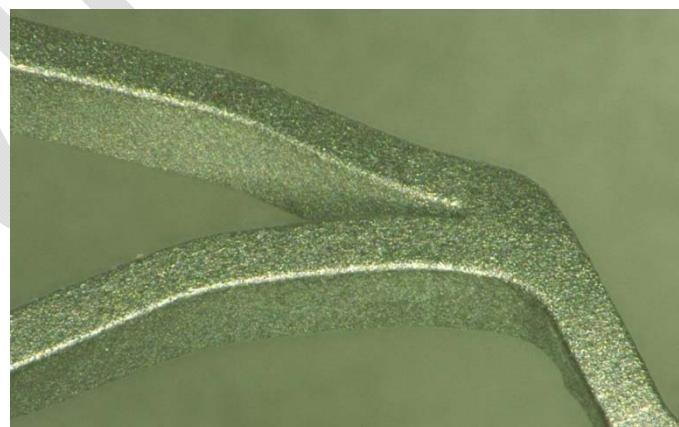
Surface finish of samples 10 & 11 (blasted at higher psi). Edges are radiused, majority of pulse lines removed.

**Conclusion:** Comco processed 7 stents for evaluation. Five of the stents were blasted at 25 psi. These stents were fully cleaned and had material removal of less than 5%. Comco also processed 2 additional stents, in order to remove the pulse lines and radius the edges. These stents were blasted at 70 psi and had substantially more material removed. The treated stents have been cleaned with air only and may have residual abrasive on them.
